# Manhole Inspection Summary

Manhole # S31A\_\_025MH

Insp Date: **12/20/07 10:34 AM**

**Location** Address: **653 PACA ST**

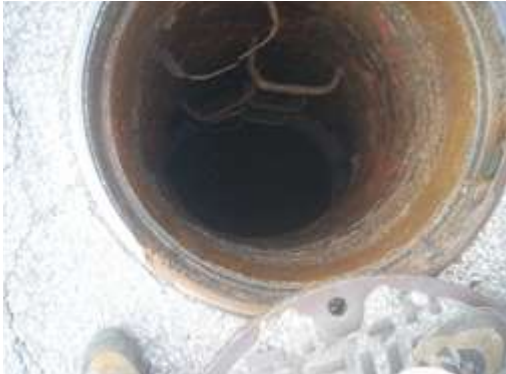
Defect 1

Count: **6** Missing: **1** ☒ **Corroded**

MISSING AND CORRODED STEPS

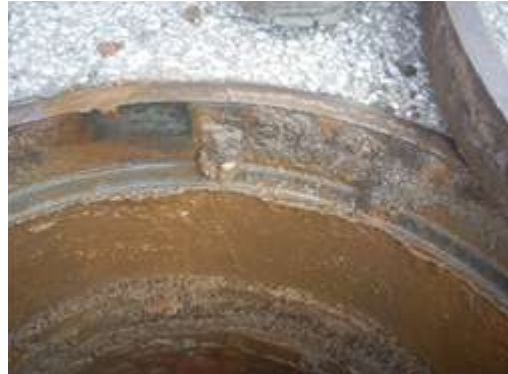
Defect 2

Condition: ☐ Sound ☒ **Cracked** ☐ Leaks

FRAME CRACKED NEAR SIDEWALK

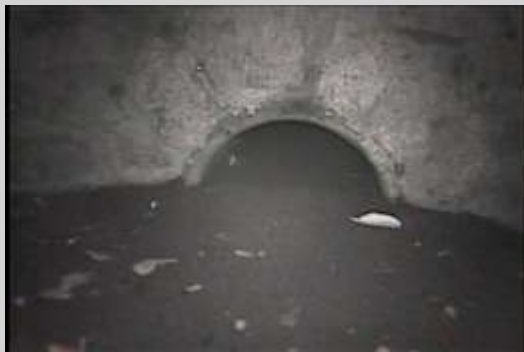
12 O'Clock Outflow

8 in. Circular Gravity Sewer  
Pipe Out @ 12 O'Clock

Deposits: ☐ None ☒ **Mud** ☐ Sludge ☐ Debris ☐ Grease

Silt Depth: **5** (in.) Deposits Extent: **Heavy**
